SAFETY DIRECTIVE AV UL/HP – 0001

INSPECTION AND/OR REPAIR TAIL POST

1.1) All Versions of Aventura UL, Aventura HP built before 2017

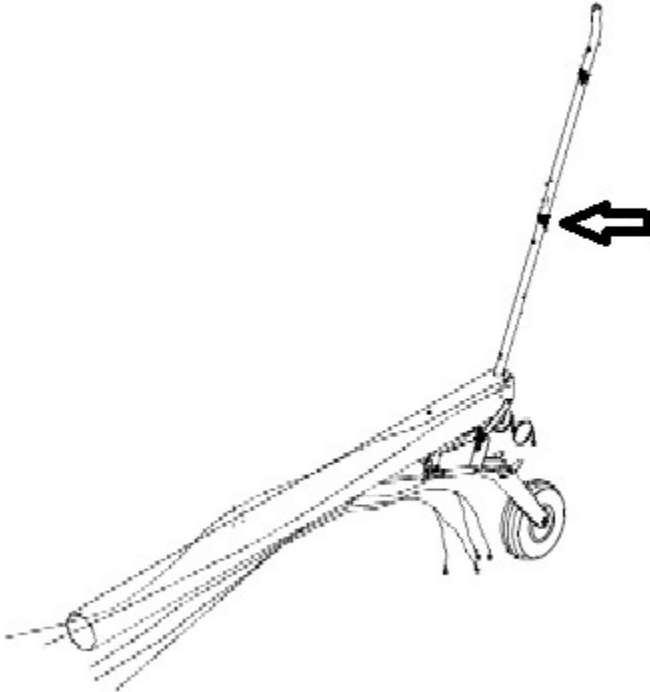
Figure 1

Field experience has shown that the rear tail post where the horizontal stabilizer channel brackets mount become cracked. Based on inspection the tail post may require replacement if cracked.

Inspect the center portion of the tail post (see Fig.1) Look for obvious fractures or cracks in the post.

whose tail post was found to have cracked it must be replaced.

NOTE: The affected tail post can be replaced by purchasing the new part from Aero Adventure.
