SAFETY DIRECTIVE AV II – 0002

INSPECTION AND/OR REPLACEMENT OF POLYMER BLOCKS

1.1) All Versions of Aventura II, Aventura UL, Aventura HP

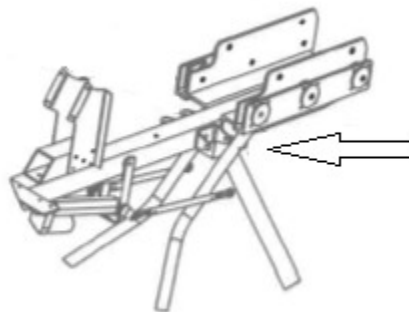
Figure 5

Inspect the upper root tube support block (see Fig. 5) to ensure that no cracking is present.

2.1.5) Any blocks inspected IAW (2.1.1, 2.1.2 and 2.1.3) whose blocks were found to have cracks must be replaced.
