SAFETY DIRECTIVE AV II – 0005

Securement of the stock Aeromomentum steel fuel rail with Aero Adventure approved method.

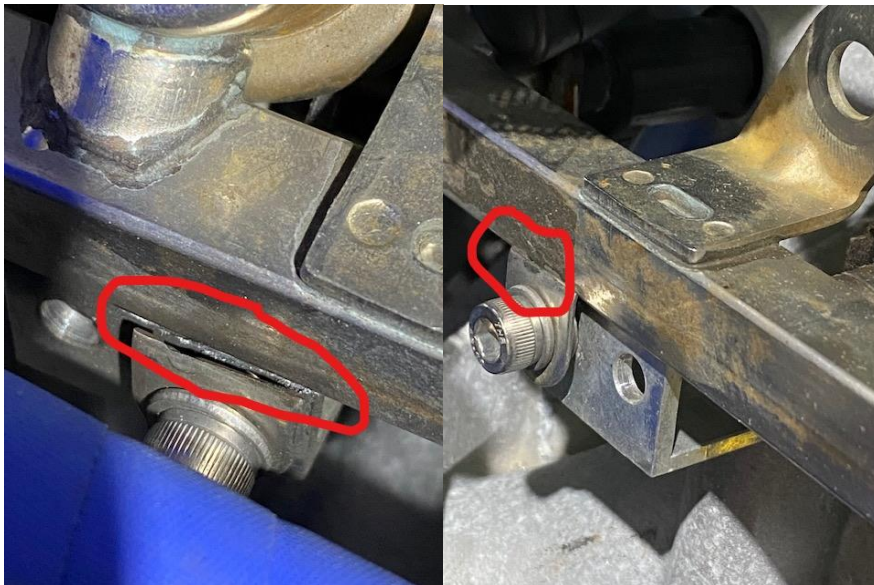
Figure 1

Field experience has shown that the steel fuel rail mounting brackets can crack leading to engine failure. Failures can cause engine out landings.

Cracked Steel fuel rail bracket.

Securement of steel fuel rail or replace with Aeromomentum aluminum fuel rail.

Before next flight, securement of the steel fuel rail must be conducted according to the Instructions provided in Section 2 of this Safety Directive.
