SAFETY DIRECTIVE AV II – 0001

INSPECTION AND/OR MODIFICATION OF CONTROL TUBE ROD END ATTACHMENT

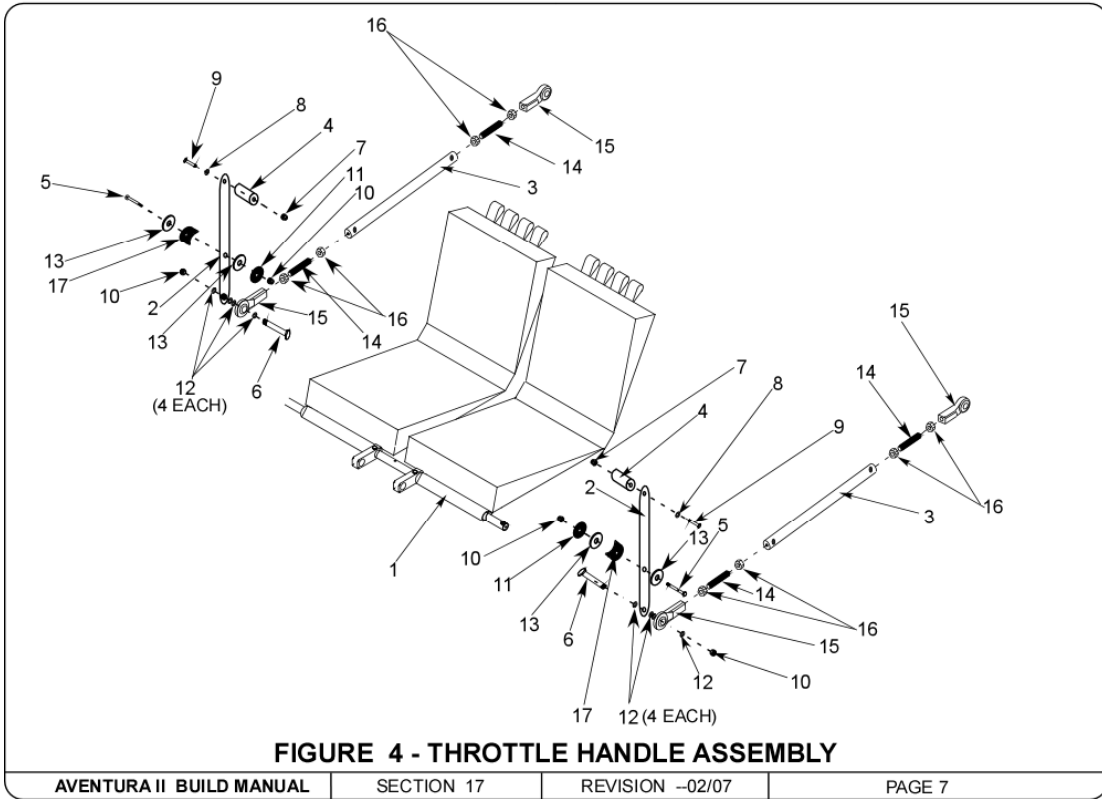
Figure 1

Inspect the Left and Right Dual Throttle Control Tubes (see Fig. 1) to ensure that the threaded inserts are secured to the tube with a solid rivet or an AN3 Bolt and Nut (see Fig. 3).

2.1.4) Any control tube inspected IAW (2.1.1, 2.1.2 and 2.1.3) whose threaded insert is not secured with a solid rivet or an AN3 Bolt and Nut must be corrected.

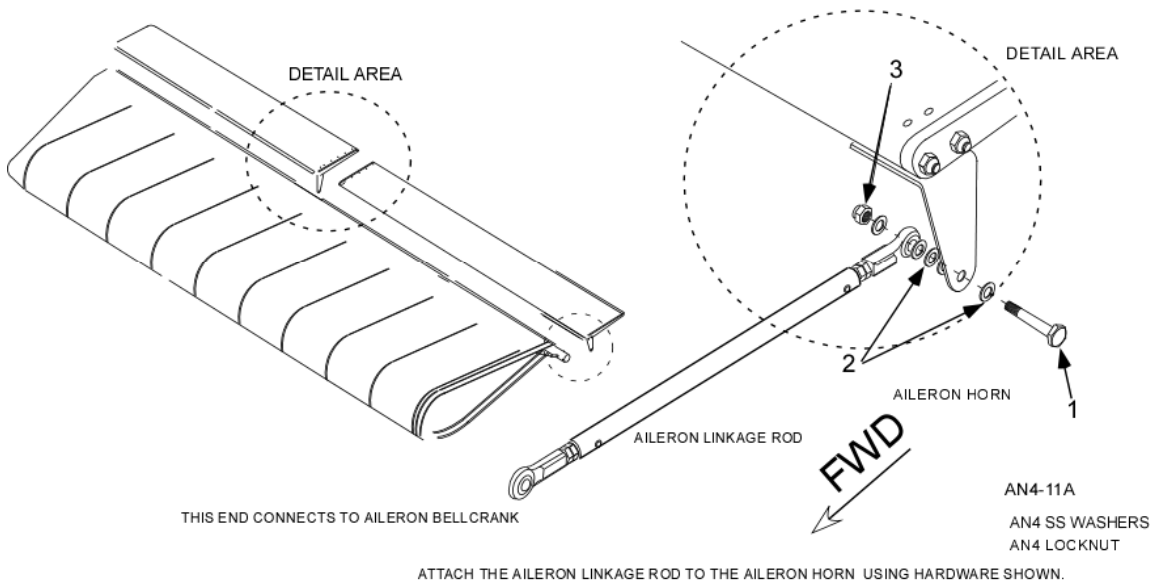
Figure 2

Inspect the Left and Right Aileron Control Tubes (see Fig. 2) to ensure that the threaded inserts are secured to the tube with a solid rivet or an AN3 Bolt and Nut (see Fig. 3).

FLAP AND AILERON CONNECTION TYPICAL BOTH SIDES

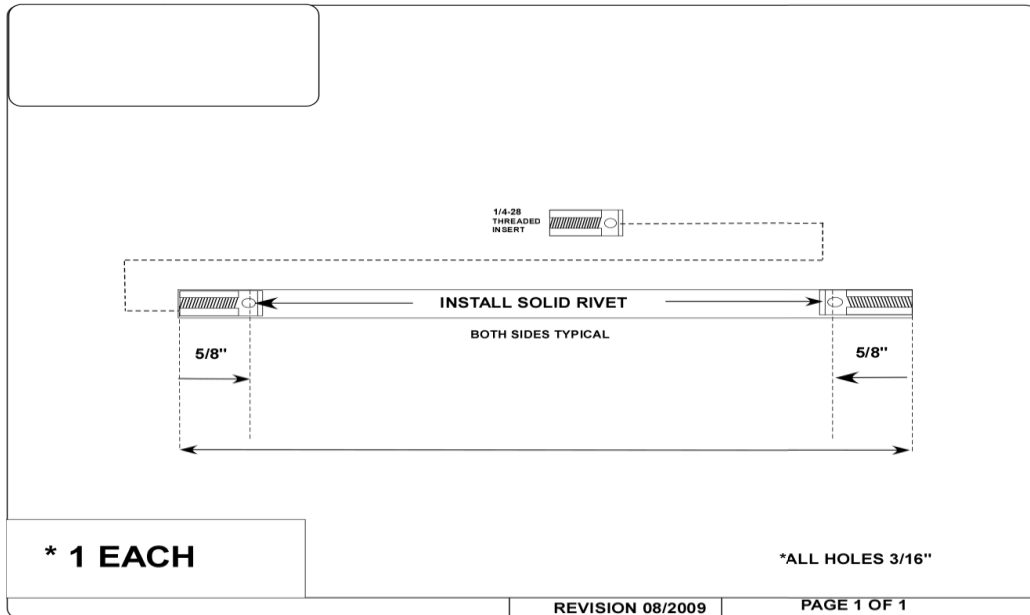
Figure 3

Field experience has shown that connection of the 1/4 - 28 threaded insert (see Fig. 3) on certain control tubes require modification due to the following: 1/4 - 28 threaded insert can separate from the control tube.

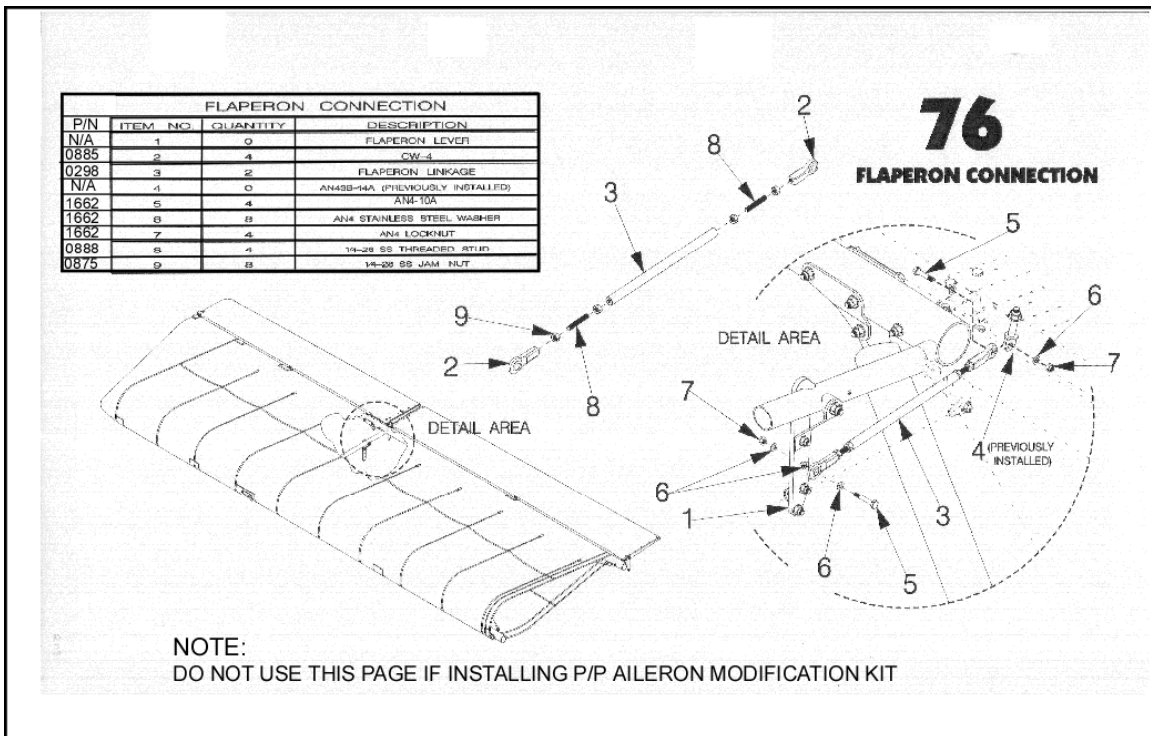
Figure 4

Inspect the Left and Right Flaperon Linkage Control Tubes (see Fig. 4) to ensure that the threaded inserts are secured to the tube with a solid rivet or an AN3 Bolt and Nut (see Fig. 3).
